Implementation Monitoring of Forestry Best Management Practices for Harvesting And Site Preparation in South Carolina, 2001-2003

Darryl Jones
Environmental Management Coordinator
South Carolina Forestry Commission

**Best Management Practices
Monitoring Report BMP-5**

Published by the South Carolina Forestry Commission
Columbia, South Carolina
January 2005

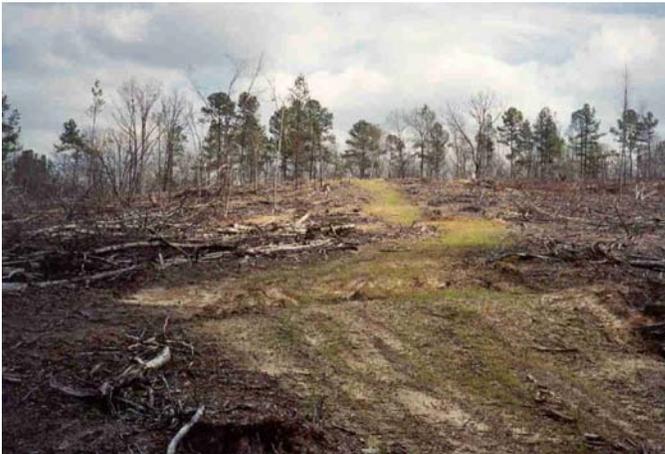
Figure 2: Haul road stabilized with vegetative cover.

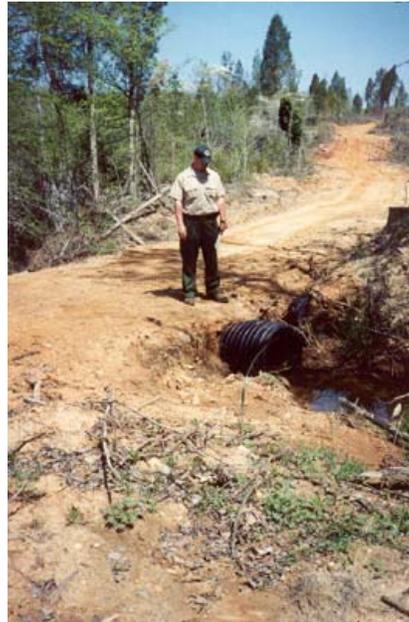
In this survey, 18 of the 200 sites surveyed for compliance with BMPs related to timber harvesting involved the construction of haul road stream crossings. Of these 18 stream crossings, 14 were designed, constructed, and maintained in compliance with BMPs. Four of the 18 sites were rated as unacceptable. Deficiencies noted with the stream crossings on the unacceptable sites included insufficiently sized culverts, lack of stabilization at the stream crossing, and poor stabilization on the approaches to the road stream crossing. Compliance with BMPs related to haul road stream crossings was somewhat lower in this survey than in the previous survey, where compliance was 86.7% (Jones, 2000).

Figure 3: Poorly installed culvert on a haul road.

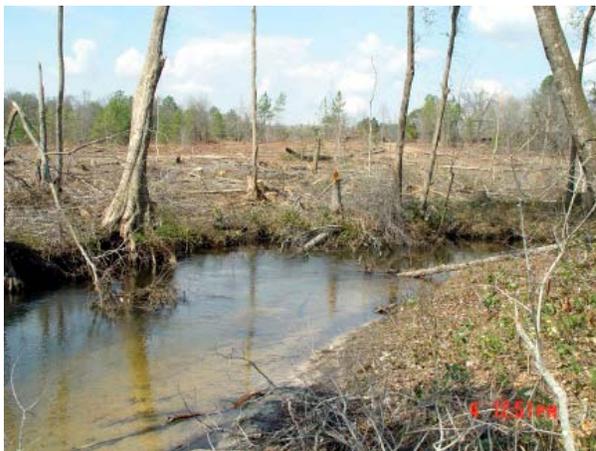
Perennial or intermittent streams were present and streamside management zones were necessary on 118 of the 200 sites included in this monitoring survey. Of these 118 harvesting operations, appropriate SMZs were retained on 103 sites. On fifteen sites, the SMZs were rated as unacceptable because forested SMZs did not meet the criteria recommended in the BMP manual. Unacceptable ratings were given when the SMZ was completely harvested (10 sites), when

Figure 4: The SMZ was harvested adjacent to this perennial stream.

insufficient overstory basal area was retained within the SMZ (5 sites), woody debris was left in the stream (4 sites), and when log decks or excessive vehicle traffic resulted in excessive bare mineral soil exposure within the primary SMZ (3 sites). Compliance with BMPs related to the streamside management zone was higher in this survey (87.3%) compared to 83.7% in the last survey (Jones, 2000).

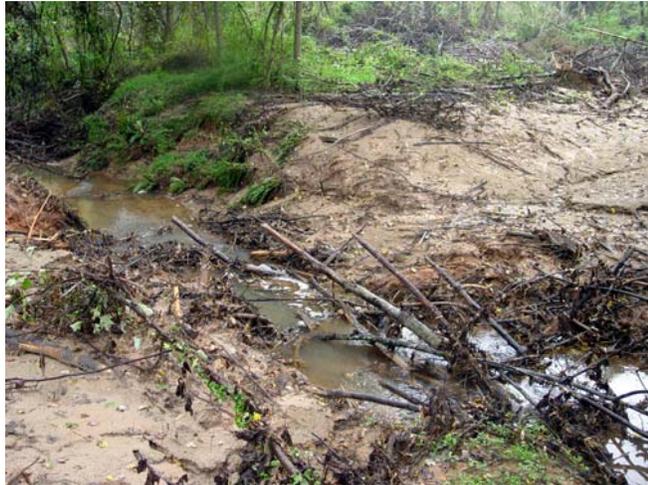
Application of the BMPs related to the harvesting operation was evaluated on each of the 200 sites included in this survey. Of these, 187 sites were rated as acceptable. When examining the logging systems on each site, the following areas were evaluated: (1) log deck location, (2) skid trail design location, (3) skid trail stream crossing design and location, (4) degree of rutting, (5) percent of the area affected by skidding equipment. A lack of stabilization on primary skid trails was the most common deficiency in BMP implementation, occurring on 8 sites. Other problems noted include poorly designed skid trail stream crossings (7 sites), poor location of skid trail stream crossings (5 sites), and placement of primary skid trails within the primary SMZ (3 sites). Compliance with BMPs related to timber harvesting was higher in this survey than the 89% compliance reported in the previous survey (Jones, 2000).

Figure 5: Poorly designed skid trail crossing left in place.

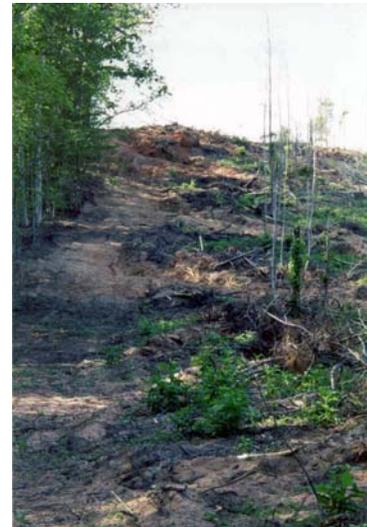
Figure 7: Bladed fireline with water bars installed.
