# Compliance and Implementation Monitoring of Forestry Best Management Practices for Harvesting in South Carolina, 2004-2005

Guy Sabin  
Environmental Program Manager  
South Carolina Forestry Commission

**Best Management Practices Monitoring Report BMP-6**

Published by the South Carolina Forestry Commission,  
Columbia, SC July 2006

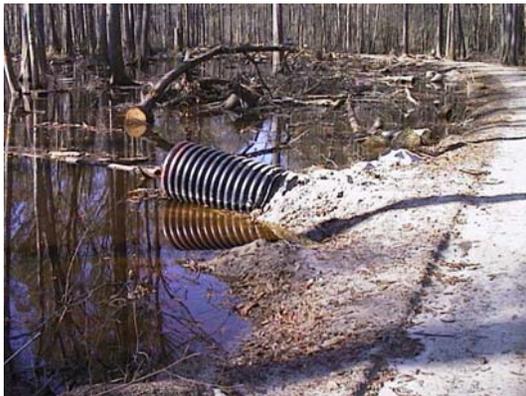
*Example of improper culvert installation.*

In this survey, 13 of the 200 sites surveyed for compliance with BMPs involved the construction of haul road stream crossings. Of these, one Piedmont site was rated as inadequate due to an improperly installed culvert which altered stream flow and caused a water quality impact.

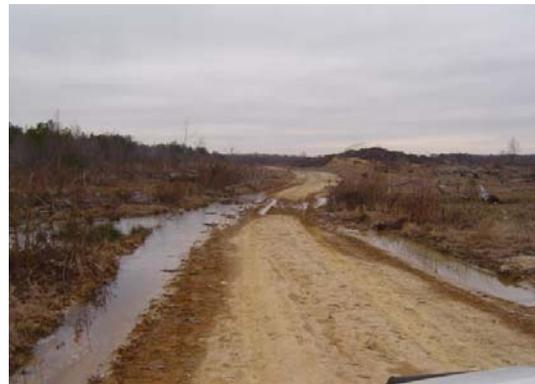
*Ephemeral stream flow is blocked by this road.*

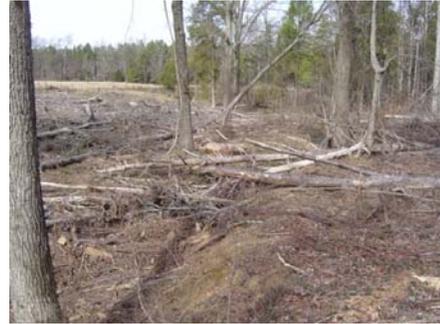
*Excessive debris in an intermittent stream.*

A total of 1,481 individual practices relative to streamside management zones were evaluated with 96.1% implementation. Five sites were noted for significant risk due to retaining less than 50 square feet of overstory basal area within the SMZ, emptying of road runoff into ephemeral areas, and failure to keep tops and other logging debris out of stream channels.

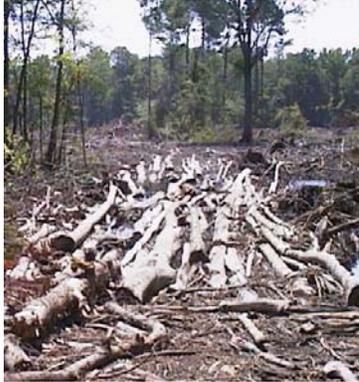
*A skid trail debris crossing.*

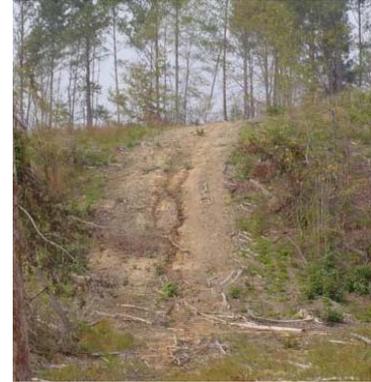
Five sites were rated as inadequate primarily because of failure to stabilize skid trails and skidding or blockage of ephemeral areas.

*A poorly stabilized skid trail.*

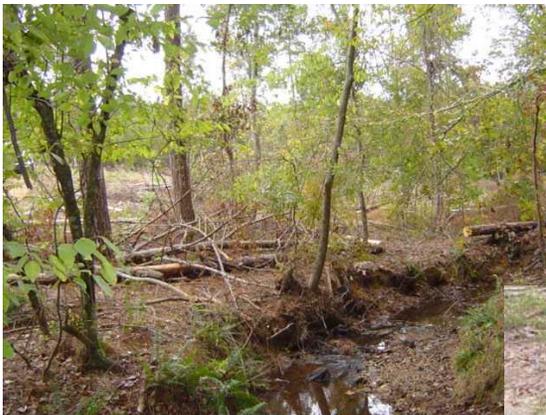
*Left: Example of an inadequate streamside management zone.*

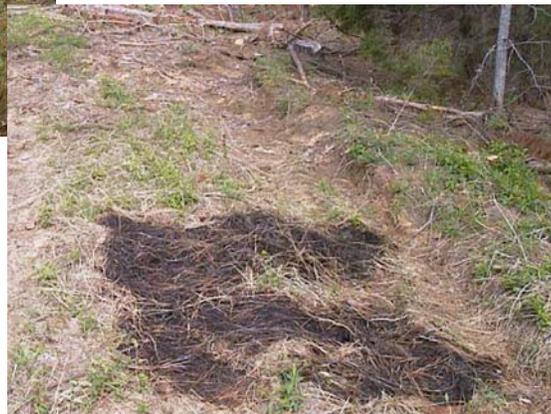
*Right: Oil spill on a logging deck.*
