FORESTRY BMPs

IN SOUTH CAROLINA

Compliance and Implementation Monitoring Report, 2011-2014

Best Management Practices Monitoring Report BMP-9, published by the South Carolina Forestry Commission, March 2015

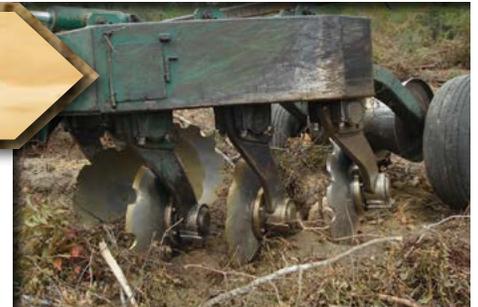
SITE PREPARATION

98.5 % Compliance

Site preparation operations were evaluated on 65 sites, including sites with mechanical site preparation, chemical application, and prescribed fire. On three sites, a combination of operations were conducted including two with mechanical and prescribed fire and one with chemical and prescribed fire. Compliance with site preparation BMPs was sufficient to protect water quality on 98.5% of these sites. One of these sites was rated with inadequate compliance in this category.

A total of 139 applicable practices were evaluated with 92.1% implementation. Eleven individual practices were not properly applied, including one with significant risk to negatively impact water quality. The most common problem noted was failure to use waterbars on firebreaks. The practice noted to have significant risk involved mechanical methods not following the contour on slopes of 11-20%.

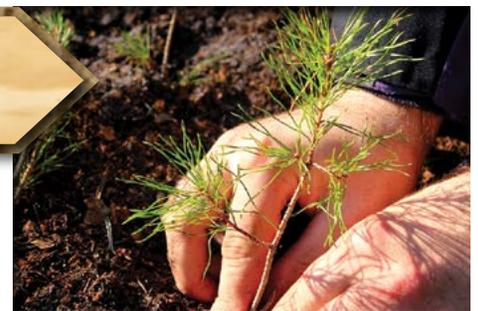
REFORESTATION

97.4 % Compliance

Reforestation activities were observed on 77 sites within two years of harvest. Forty-nine sites were hand planted and 28 sites were machine planted. Compliance with BMPs related to reforestation was 97.4%, with two sites rated as having significant risk to negatively impact water quality. Both sites were located on industry-owned¹ land in the Piedmont region of the state. Causes for concern on both included machine planting in, through, and down ephemeral streams and machine planting on steep slopes.

A total of 114 applicable BMPs related to reforestation were evaluated with 93.9% implementation. Seven practices were not implemented including two with significant risk to negatively impact water quality. Problems included failure to hand plant on steep slopes with erodible soils, not machine planting on slopes >5% and the presence of planting bags or garbage associated with planting.

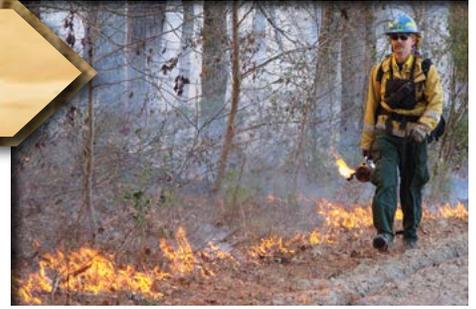
PRESCRIBED BURNING

85.7 % Compliance

Prescribed burning was evaluated on seven sites, and compliance with BMPs was sufficient to protect water quality on 85.7% of those sites (6 of 7). One site was rated with inadequate compliance in this category.

A total of 37 applicable BMPs were evaluated with 81.1% implementation. Problems statewide included the absence of waterbars in firebreaks and the failure to use hand tools to tie firebreaks into streams.

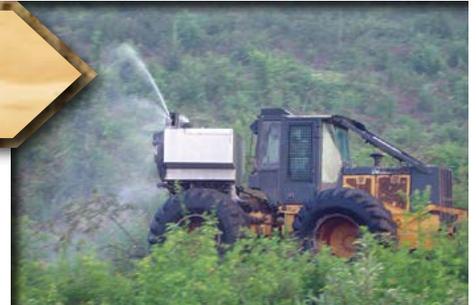
PESTICIDE APPLICATION

100 % Compliance

Pesticide application was evaluated on 33 sites and compliance with BMPs was sufficient to protect water quality on 100% of those sites. A total of 159 applicable BMPs were evaluated with 100% implementation. No sites in this survey were identified with fertilizer application.

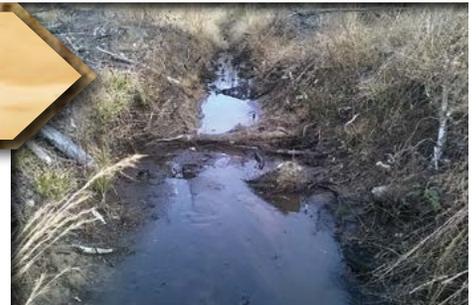
MINOR DRAINAGE

100 % Compliance

Seven sites in this survey included activity related to pre-existing minor drainage. No new minor drainage was identified. Compliance with BMPs related to minor drainage was sufficient to protect water quality on 100% of sites. A total of 64 applicable BMPs were evaluated with 93.8% implementation. Problems included possibly using the 404 silvicultural exemption of the Clean Water Act for non-silvicultural objectives and minimizing the depth, width, and number of ditches. However, since these were pre-existing drainage features, it is difficult to discern whether they were dug prior to the implementation of the Clean Water Act.

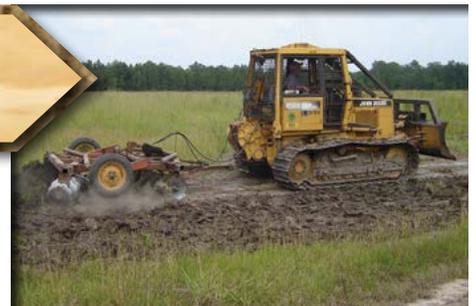
OVERALL NON-HARVESTING COMPLIANCE

96.6 % Compliance

Compliance with non-harvesting BMPs was sufficient to protect water quality on 96.6% of sites (86 of 89). One site rated excellent, 85 sites rated adequate, and three sites rated inadequate with compliance to BMPs. Two sites rated inadequate were due to machine planting on erodible soils and through ephemeral drains. The other rated inadequate was due to erosion from firebreaks. All three inadequate sites were on industry lands in the Piedmont region of the state.

A total of 513 applicable non-harvest BMPs were evaluated with 94.35% implementation. Twenty-nine individual practices were not properly applied.

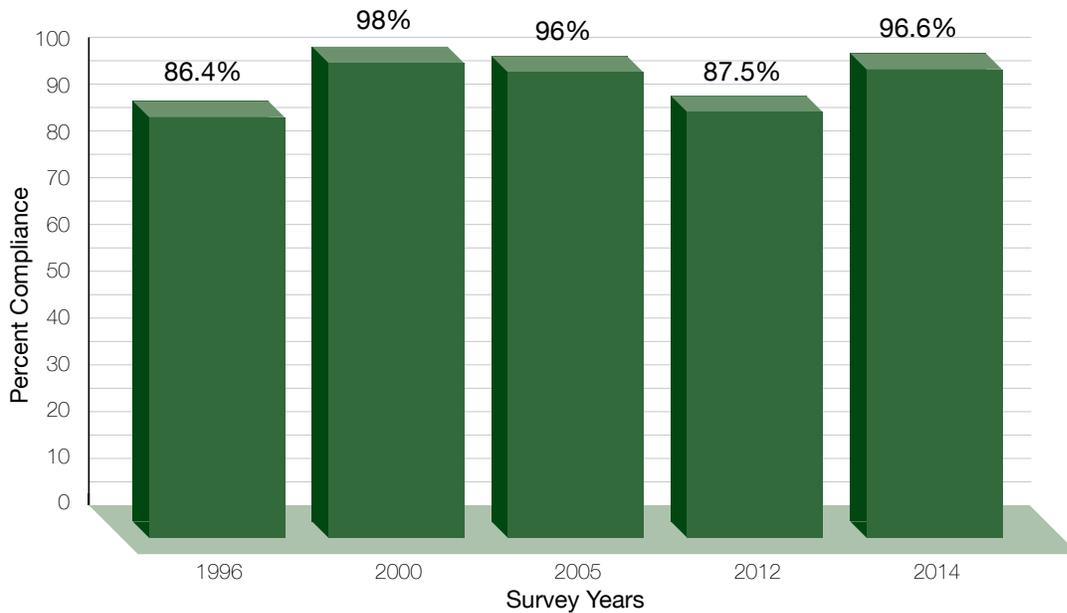
TABLE 1

Overall Non-Harvest Compliance By Year

The dip in compliance of 87.5% for the 2012 survey is most likely just due to sampling error. Only 16 sites were evaluated for non-harvest activities in 2012 giving a sample size that does not lend itself to testing statistical significance.

Overall compliance for non-harvest activities for this survey was 96.6% (Table 1). This is near the all-time high of 98% for South Carolina in 2000, but reforestation and minor drainage were not evaluated in that survey. The overall rating indicates that landowners and forestry professionals are committed to protecting water quality through proper implementation of Best Management Practices for Forestry.

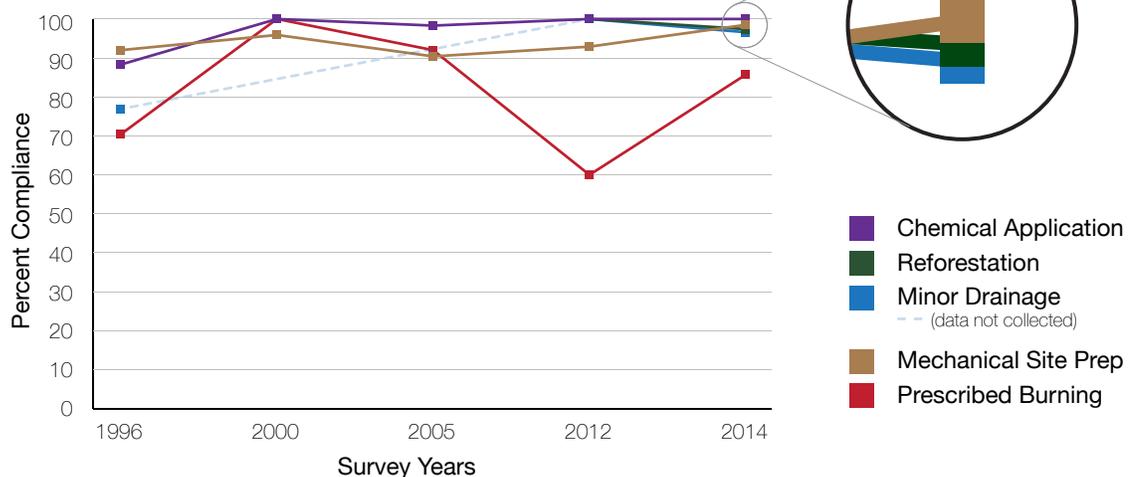
TABLE 2

Non-harvest compliance for chemical application and minor drainage was 100%, while mechanical site preparation reached a new high compliance rate of 98.5%, (Table 2). Prescribed burning had the lowest compliance at 85.7%, but shows improvement over the last survey.

Non-Harvest BMP Compliance Trends By Category

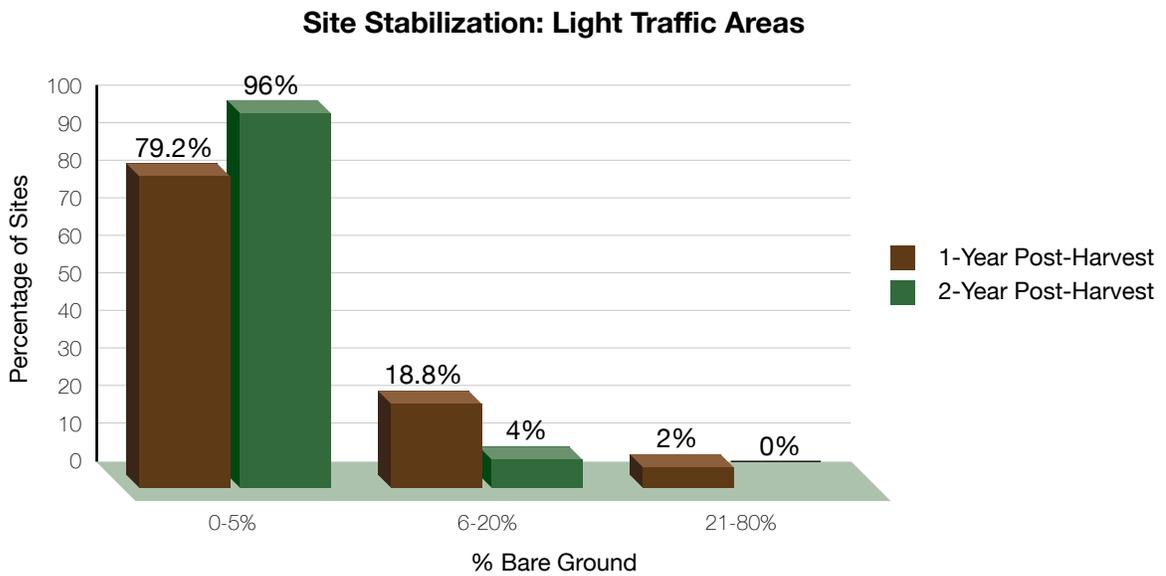
TABLE 3

The degree of site stabilization was estimated one year post-harvest and two years post-harvest on both light and high traffic areas. One year post-harvest, 79.2% of sites had a high degree of stabilization on light traffic areas (0-5% bare ground) (Table 3). On high traffic areas (Table 4), such as log decks and main skid trails, 49.0% of sites had high stabilization with 0-5% bare ground and 85.2% had less than 20% bare ground. Two years post-harvest, 96.0% of sites had a high degree of stabilization on light traffic areas, and 79.9% of sites with high traffic had 0-5% bare ground and 94.6% of sites had less than 20% bare ground.

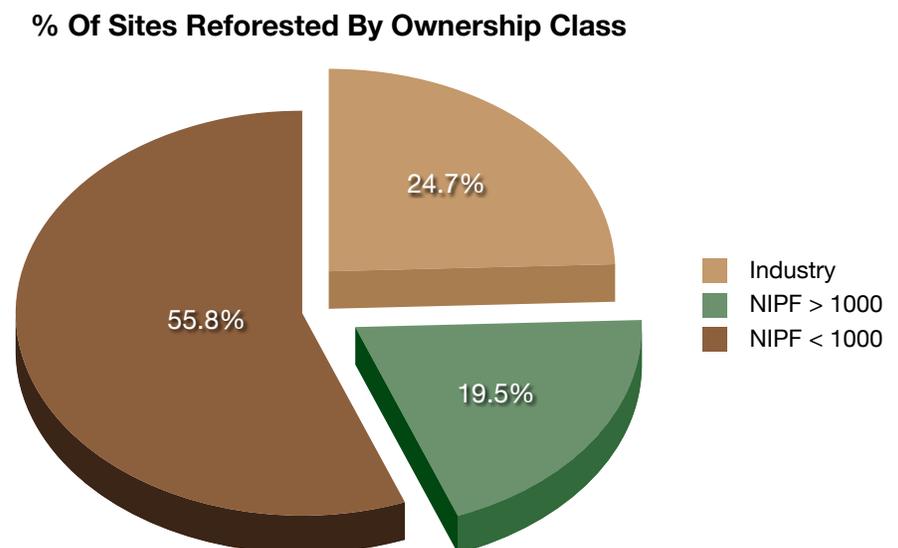
TABLE 6

Of the 77 sites artificially regenerated, 24.7% (19 sites) were owned by forest industry, 19.5% (15 sites) were owned by non-industrial private landowners owning more than 1,000 acres, and 55.8% (43 sites) were owned by non-industrial private landowners owning fewer than 1,000 acres (Table 6).

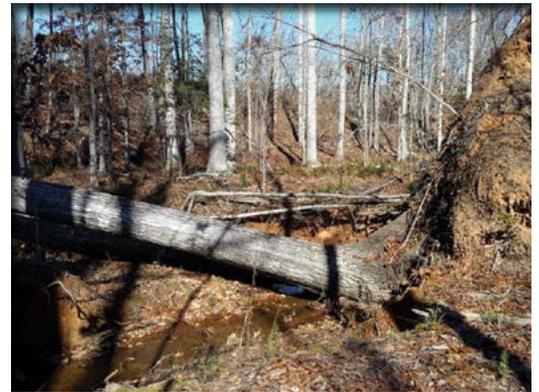
Blowdown In SMZs

Streamside Management Zones (SMZs) are a crucial part of Best Management Practices and essential to protect water quality. SMZs function to filter nutrients and sediment before runoff reaches the stream channel and also provide shade to the stream resulting in lower water temperature. SMZs also serve as habitat and travel corridors for many species of bird, mammal, and amphibian. However, often the residual trees left in SMZs are subject to be blown over due to moist soil conditions, root patterns of the residual trees, and as a result of being exposed to the wind when the rest of the adjacent stand has been clearcut.

For this survey, 42 sites contained SMZs. Of these, 27 had blowdown within the SMZ. Seventy-five total trees were blown down on these 27 sites. Oak (*Quercus* spp.) was the most common species downed by wind accounting for 44% (33 trees) of windthrow (Table 7). The next most common species was sweetgum (*Liquidambar styraciflua*) with 25.3% (19 trees). The least common windthrown species were yellow poplar (*Liriodendron tulipifera*), hickory (*Carya* spp.), and other hardwoods with 2.7% (2 trees) each.

This survey was also able to tell us that oak is the predominate species susceptible to blowdown in SMZs around perennial streams. This information could be used to guide selective harvesting within the SMZ.
